AFML-TR-72-122

DYNAMIC AND STATIC EVALUATION OF EXPERIMENTAL INTEGRAL FUEL TANK SEALANT MATERIALS

This Final Report was prepared by Encapsulants and Sealants Technical Service and Development Laboratory, Dow Corning Corporation, Midland, Michigan, under Contract No. F33615-70-C-1422, Project No. 7340, "Nonmetallic and Composite Materials", Task 734005, "Elastomers and Compliant Materials", and covers work performed during the period 1 May 1970 to 1 April 1973. The sponsoring agency is the Elastomers and Coatings Branch, Nonmetallic Materials Division, Air Force Materials Laboratory, Wright-Patterson Air Force Base, Ohio. The Project Engineer is Mr. W. F. Anspach (MBE).

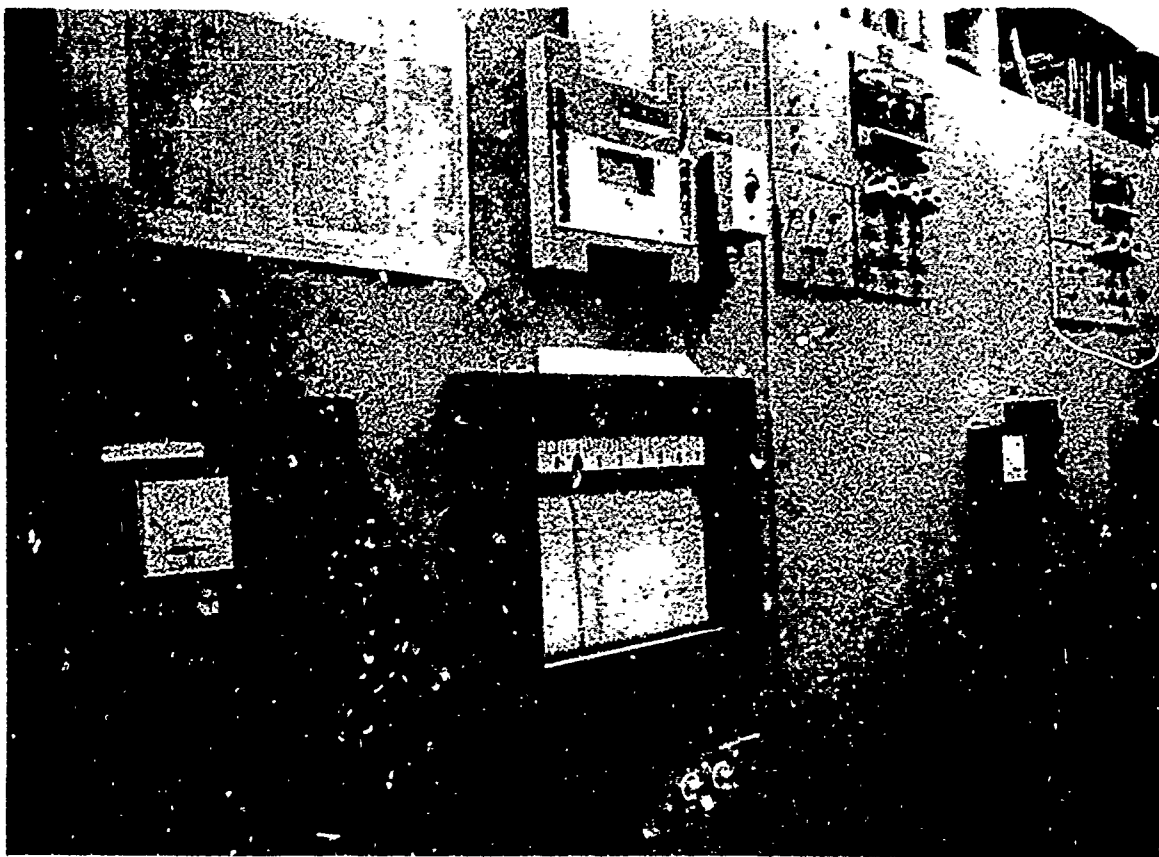
FIGURE 6

MASTER CONTROL PANEL

INDIVIDUAL UNIT CONTROL

Based on specifications set forth at the inception of this contract, as well as the information summarized in the preceding section, the dynamic test device (refer to Figures 3 through 6) was designed to include the following capabilities:

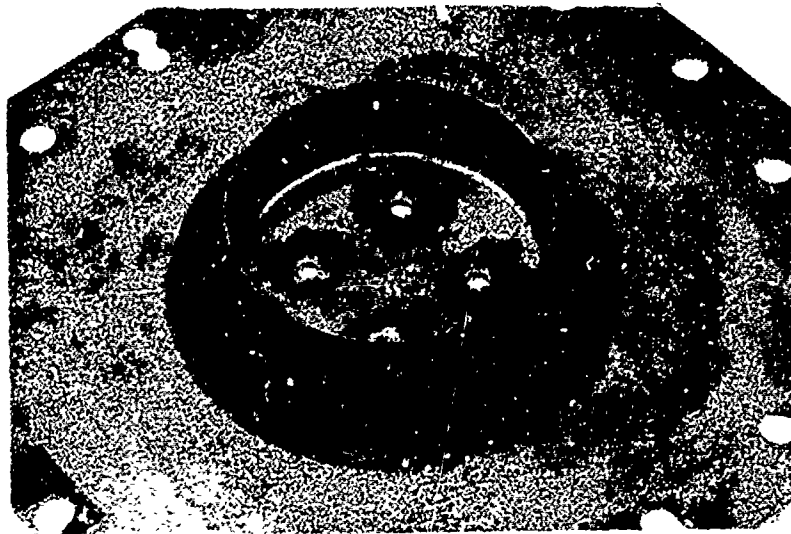
Over-head X-Ray of Specimen

X-Ray at 30° Angle

FIGURE 16 - X-RAY EXPOSURE OF SPLIT FAILURE ON DOW CORNING 95-526

Recently a technique was used on several specimens for determining the internal failure pattern on specimens which had leaked. It was shown that a flowable silicone fluid/lead salt paste could be drawn through the ruptured specimens under vacuum, thereby filling the leak path with a relatively radio opaque material. By exposing the specimens, backed with Polaroid film, to x-ray it was then possible to obtain photographs of the internal size and shape of the leak paths (Figures 15 and 16).
